# Effect of Use of Geocell and Rice Straw in Slope Stability

**Abstract:** *One of the most difficult challenges in geotechnical engineering is slope failure caused by soil erosion during rain. The geocell structures and rice straw reinforcement are used to create a composite soil treatment and slope protection approach. The geocell structures improve the planting soil's stability and provide a stable and fixed habitat for the vegetation, while the rice straw strengthens the soil while also increasing its fertility. The progression of slope failure during rainfall, soil erosion and slope displacement were all evaluated. The findings reveal that when rainfall persists, slope failure occurs, and soil deterioration increases with rainfall intensity. Although geocell treatment enhances slope stability, geocell with rice straw composite reinforcement provides the best erosion control and slope protection. The result shows that use of geocell improve slope stability, but geocell and rice straw composite shows best erosion control and slope stability.*

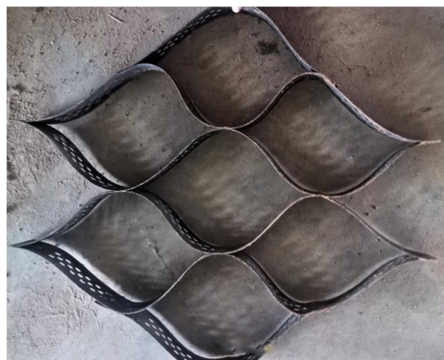
Fig 1: Geocell

Geocell is a geosynthetic material that is commonly used in soil reinforcement and erosion control operations. EGS Geocell is a three-dimensional structure built of high-density polyethylene (HDPE) strips. It has the ability to expand on-site to produce a honeycomb-like structure that may be filled with sand, dirt, rock, gravel, or concrete. Geocell is collected from TECHFAB Industries Ltd.

Table 1 shows the properties of geocell purchased from TECHFAB Industries Ltd.

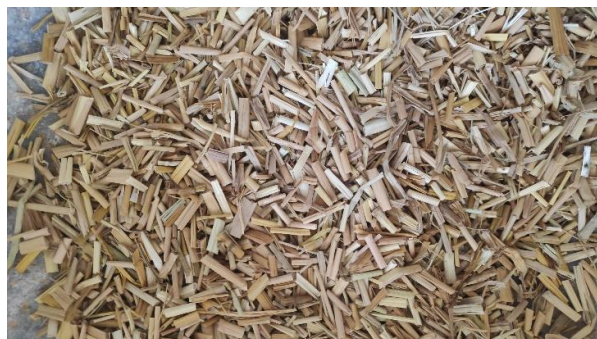
Fig 2: Rice straw

Rice straw is added as crumbles having size variation of 5mm to 10mm. About 1.5% of the rice straw crumbles are added to soil to improve the properties of the slope soil. When straw is mixed with soil, the weight of the straw steadily reduces as microorganisms multiply and break down the straw. The breakdown of wheat straw improves soil fertility by supplying nitrogen or other nutrients and encourages the growth of plants planted on the slope. The plant's root system reinforcing the geocell-reinforced soil, which enhances slope stability even further.

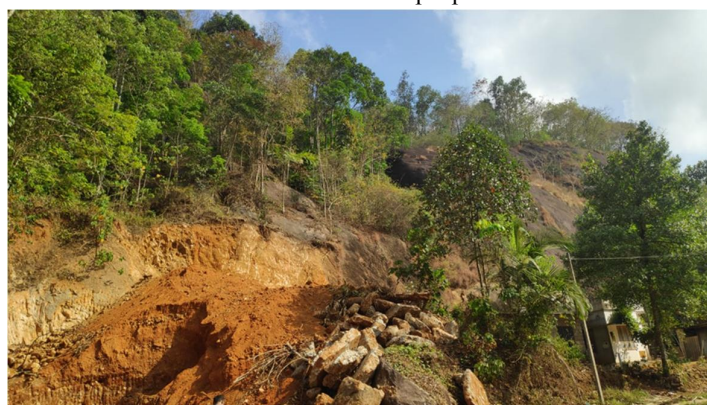
Soil is collected from selected site Amboori, Thiruvananthapuram, Kerala where several slope failures have occurred. Amboori is situated in the southern tip of western ghats, surrounded by hills and is near to kattakkada. Amboori has witnessed a large landslide in 2001 which claimed the life of 39 people.

Fig 3: Soil collected from Amboori.

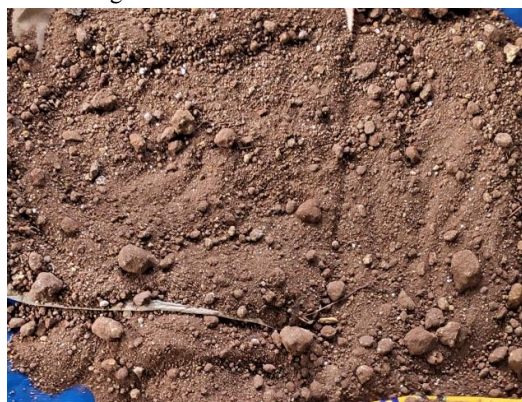
Fig 4: Soil sample collected.

The soil sample collected from an average depth of 4m from the ground surface. The soil is sundried for several days and tested for its geotechnical properties.

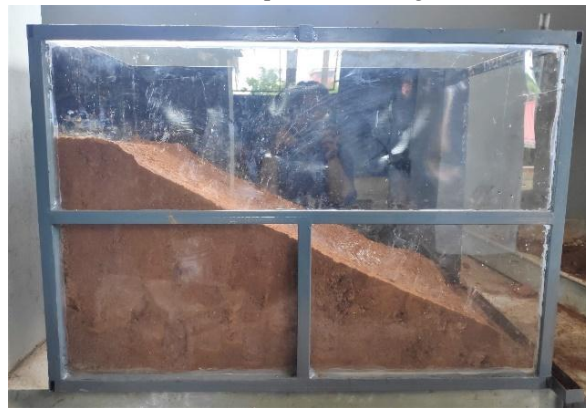
Fig 5: Steel Tank

The steel tank has a dimension of 1m×0.5m×0.7m. Polycarbonate material is used for front portion for viewing the failure mechanism. Bottom back and side portion of the tank is constructed using metal. One side of the tank remains vacant. An outlet is provided at the vacant side to collect the runoff provided during the simulated artificial rainfall.

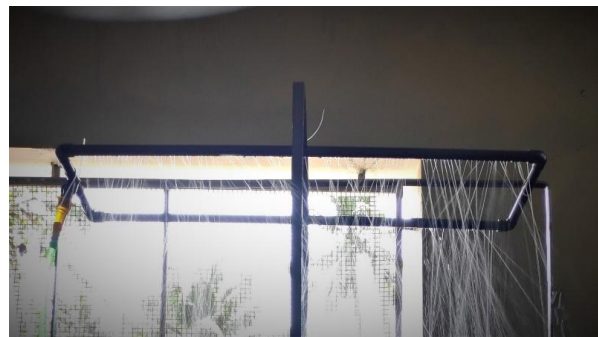
Fig 6: Artificial rainfall system

Artificial rainfall system is implemented along with the steel tank to provide average intensity of rainfall from the site selected. The average intensity of rainfall from the site is calculated from SODA Merri-2 software and is recorded as 165mm/hr.

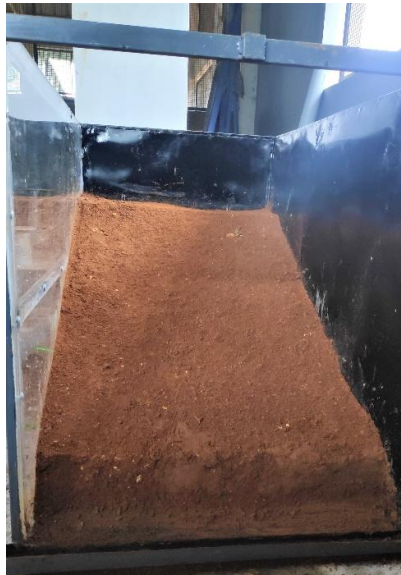
Fig 7: Natural slope before simulated rainfall

Natural slope is created at an angle of 32° by compacting the soil in layers. The heel and toe of the slope is created. The artificial rainfall simulator provide rainfall at the rate of 165mm/hr.

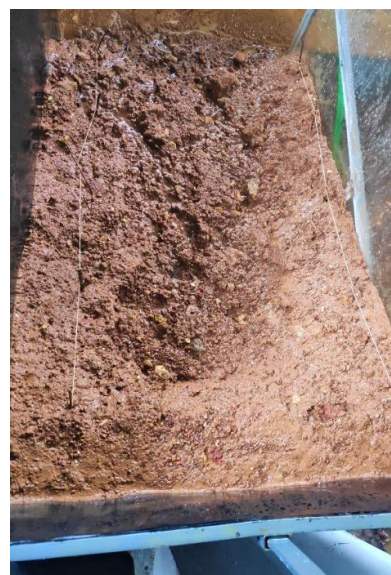
Fig 8: Natural slope after simulated rainfall

In natural slope the slope fails at faster rate compared to other two slopes. For the first 5 to 10 minutes the toe portion of the slope fails gradually. At the end of 30 minutes the slope gets eroded gradually to the heel portion of the slope. The slope gets displaced to a maximum value at the end 60 minutes.

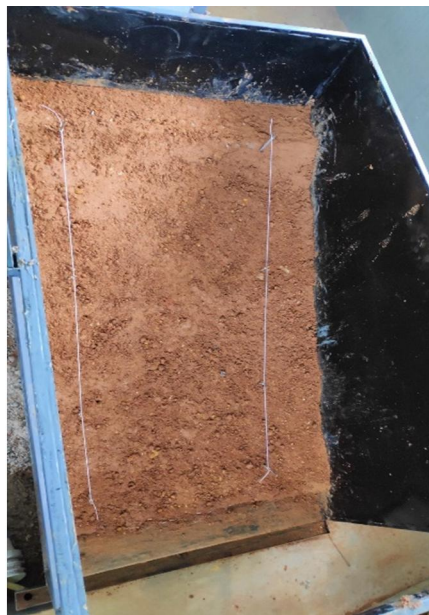
Fig 10: Geocell supported slope before simulated rainfall

Geocell supported slope is constructed by placing the soil in the steel tank layer by layer and compacting to its maximum dry density. In the top 10cm of the slope, geocell is placed and voids between the geocell is filled with soil and compacted. The slope is compacted and placed neatly.

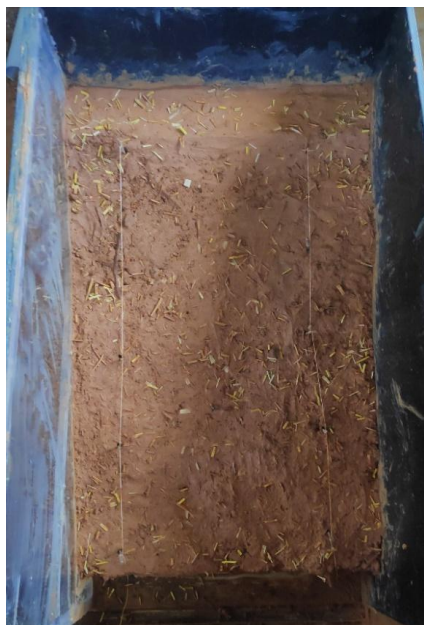
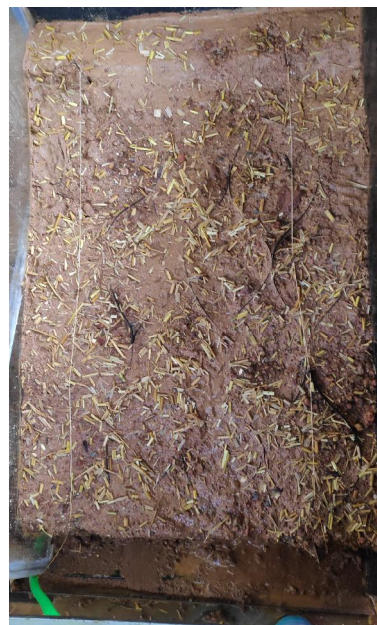
Fig 12: Composite reinforced slope before simulated rainfall

Fig 13: Composite reinforced slope after simulated rainfall

Fig 12 and 13 shows composite reinforced slope before and after simulated rainfall. The composite reinforced slope shows less erosion and soil displacement. It shows only 3mm of soil displacement at the end of 60 minutes of artificial rainfall. The rice straw keeps the slope intact and more stable in nature. A small portion of the soil is only eroded at the end of the simulated rainfall.

Composite reinforced slope consist of Geocell and rice straw placed in combination. The soil is placed in such away the bottom layers of the soil is placed and compacted and the geocell is placed in the formed slope. Soil mixed with rice straw is placed and compacted within the geocell for a depth of 10cm of the slope. The rice straw give better stability and reinforcement to the soil.
