New Materials and Techniques for the Repair and Restoration of the Heritage Structure

The restoration of the Bombay High Court's main building was looked into to gain a better knowledge of how conventional restoration work is done in India. The Bombay High Court is a Social Monument and a Heritage Structure of Grade II-A. The structure of the Bombay High Court has been preserved. After 150 years, it is still standing. The building has a beautiful north-facing double-steeple roof and magnificent Venetian balconies, all of which are surrounded by lancet-arched passages. It is made of the same dark basalt, interrupted by soft Pounder stone and heightened in parts with red sandstone and buffed basalt, making it easier to merge with the current foundation of the High Court. Chipped floors, dangling brass drops, missing cast-iron rails, leaking ceilings, corroded sculpted figures, and clogged gargoyles have all survived to tell the story of the destruction.

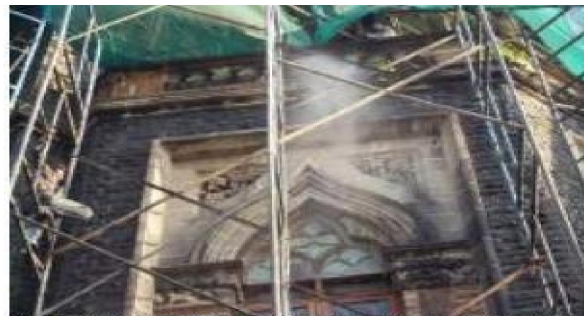
Using misting technique to remove years of dirt, dust and pollution.

Problem - The exquisite decorations of the façade were dark, stained, and chipped unattractive due to years of pollution, dust accumulation, and natural weathering. Some of them were also producing slight leakage into the walls' inner surfaces. Water and surfactants were used to clean the continuous basalt façade surfaces without destroying the stone. Specialized techniques including sand and copper blasting were used in places with severe façade damage and thick layers of dust. After washing the façade, the stone masonry joints were meticulously re-pointed with lime mortar.

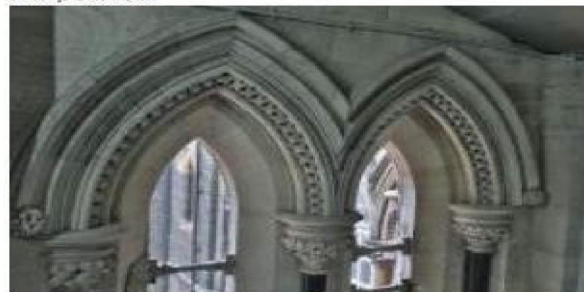
Pictures showing cleaned, restored stone walls, arches

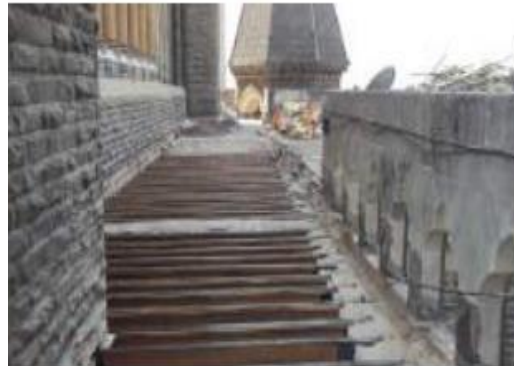
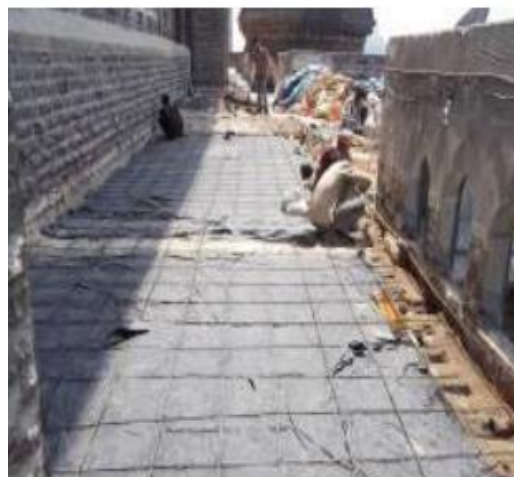
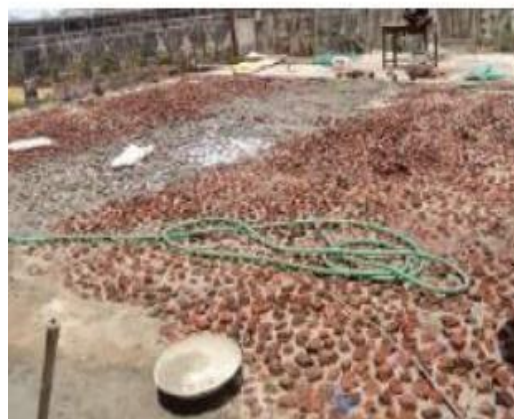
Terrace Waterproofing

Multiple layers of waterproofing had to be dismantled to restore the flat terraces, the damaged rafters had to be replaced, and the boarding had to be repaired over it. After that, a layer of brickbat Coba and reinforced bitumen tar felt was applied to avoid any water seepage. It was finished with a cement mortar layer combined with waterproofing chemicals after the requisite slopes were provided

Fixing additional 8mm thick M.S plates over each rafter increased the load-bearing capability of the rafters. R.C.C. slabs were to be cast over the teak wood boarding that had been installed over the rafters. The ends of the rafters were covered with a layer of Black Japan and polythene sheets before being buried in the walls during the restoration. The boarding was also bitumen coated to lessen the impact of moisture exposure on the wooden sections, extending the life of all members.
