Restoration and Feasibility Study for Development of Sunkalpalya Lake

Dr. P. Nagabhushan¹, Diganth J Lokesh², Modak C Basappa^{3,*}, Vidya Sagar D. V⁴, Skanda S Bhat⁵

Department of Civil Engineering^{1,2,3,4,5}

JSS Academy of Technical Education, Bengaluru, India

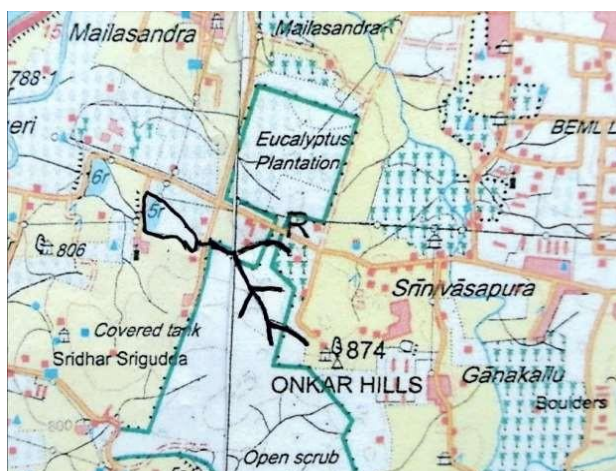
Figure 3: Map showing Drainage network of Sunkalpalya lake

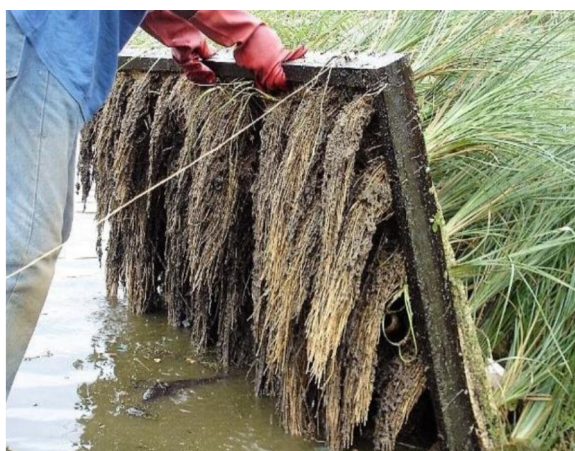
Figure 4: Vetiver grass wetland plantation system

- **Design of Sewers:** Storm water and sewage water drain was done to avoid mixing of storm water and sewage water. Proper disposal of storm water into the lake and diverting sewage away from entering lake, with thorough inspection with the help of manholes was done. With the help of rational formula method and mannings formula, storm water and sewage water drains of circular cross sections diameter were determined.
- **Use of Vetiver Grass Wetland Plantation System:** It is a type of restoration technique wherein vetiver grass is grown as wetlands in the lake and its root absorbs the enriched contaminants of the lake water such as nitrates and phosphates. Since it is a perineal plant, it can be used in more effective manner, low cost and when it is dried up it can be used as fertilizer for plants as well.

Once the analysis of various water quality parameters was done, it was found that the water is polluted in small extent. So vetiver grass was used to reduce the level of pollution. Diameter of 200mm and 150mm circular cross sections for storm water and sewage water drain were used respectively. Below table shows the water quality parameters before and after the use of vetiver grass in center lake water.
