Evaluation of Fire Protection Systems in Multiple Use High-rise Buildings for Fire Safety Optimization

Pravin Tathod[1] and Kamlesh Mishra[2]
Professor[1] and PG Scholar[2]
Shiv Kumar Singh Institute of Technology and Science, Indore, Madhya Pradesh, India

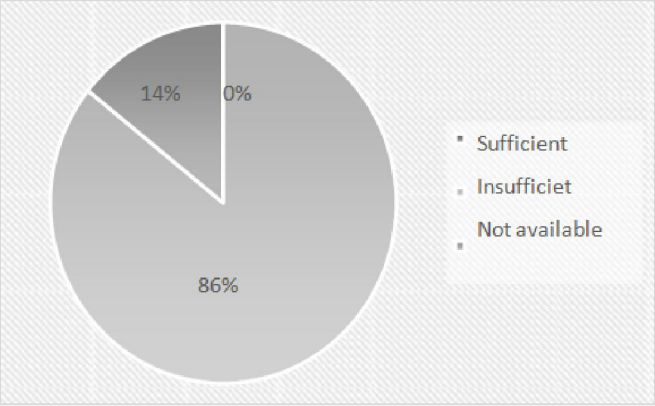
Figure 1: The proportion of buildings with or without sufficient and or/ suitable automatic water sprinkler system

Automatic water sprinkler system: Although 85.71% of the buildings in the sample were found to be installed with water sprinkler systems, they exhibited insufficiency, while 14.29% had no sprinkler systems at all.

Visual observations and review of internal and external inspections and maintenance reports showed that damag sprinkler heads, poor housekeeping (leading to dusty conditions which could trigger activation of alarm system), inadequate reserve water and poor implementation of the maintenance program after inspection as key factors that rendered the system insufficient. According to the fire experts in the construction industry, cost factors in installation of sprinkler systems is very high and it times can escalate the cost of a project by three percent up hence making distribution limited to basements only. According to the Fire brigade fire investigations none of the sprinkler systems in buildings have ever actuated during fire episode hence putting doubt to their effectiveness. From the findings of the

study, it's critical that, apart from provision of sprinkler systems they be inspected, tested and maintained at all times. It is also important that housekeeping is maintained to prevent unwanted alarms.

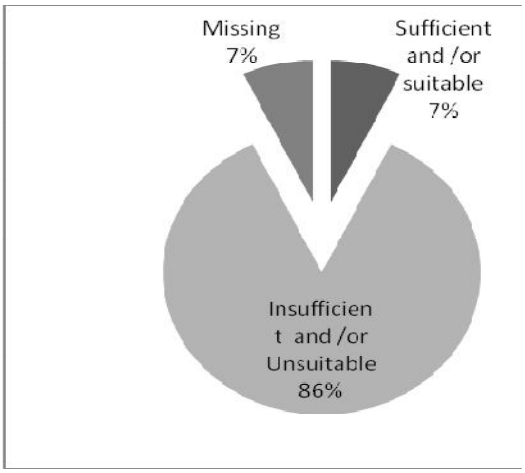
Figure 2: The proportion of buildings with or without sufficient and or/ suitable automatic fire detection and alarm system

Fire detection and alarm system: The essence of an alarm system is to detect fire and/or smoke and keep the building occupants and fire attendants alert and evacuate the buildings if the danger of fire became eminent. In the survey all the buildings were found to be installed with an fire detection and alarm system. However deficiencies persisted. In the survey, it was found that 57.14% of the buildings had a sufficient and suitable fire detection alarm system. However, 42.86% exhibited insufficiency or unsuitability.

Data from the responses from building managers, fire experts and occupants indicated that the shortfalls on fire detection and alarm system originate from maintenance-related issues such as rampant false alarms due to poor house-keeping (dusty conditions), smoke from smoking and kitchen, component loss or breakdown or sheer lack of maintenance. To achieve a reliable fire and alarm system, there is a need to maintain cleanliness in the buildings, conduct regular inspections and implementable maintenance schedules. There is also a need education or awareness creation among the occupants.

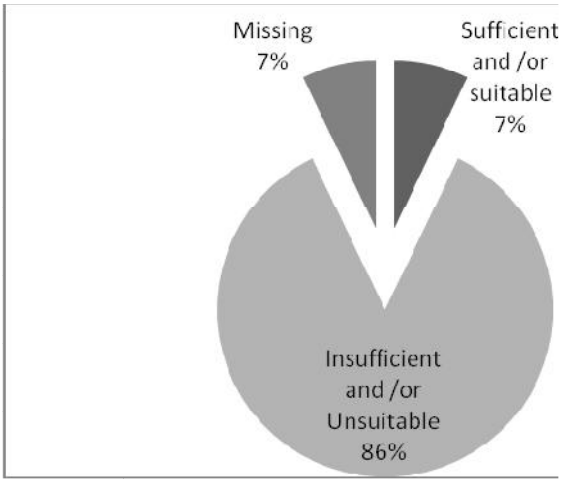
Figure 3: The proportion of buildings with or withoutsufficient and or/ suitable fire escape route

Escape route: In the survey it was found that only 7.14% of the buildings had sufficient or suitable means of escape to safety, 85.71% were found to insufficient and/or unsuitable fire elements and 7.14% had no escape stairs or other means ofescape.

In the survey it was found that the deficiencies are in escape routes are connected to such factors as unclear or no exit signage leading to difficulties in finding the exact location of the escape route, obstructions, locking, etc.; smoke entering the escape route and escape stair due to poor escape route planning and the condition of fire doors, that is, either broken, locked, not self- locking etc. Inspection and maintenance is essential to achieve a safe (free of any obstructions) escape route. It should be well light and provided with essential furniture to aid in movement and visibility of the route. The occupants should be inducted on the use of the escape routes through fire drills.

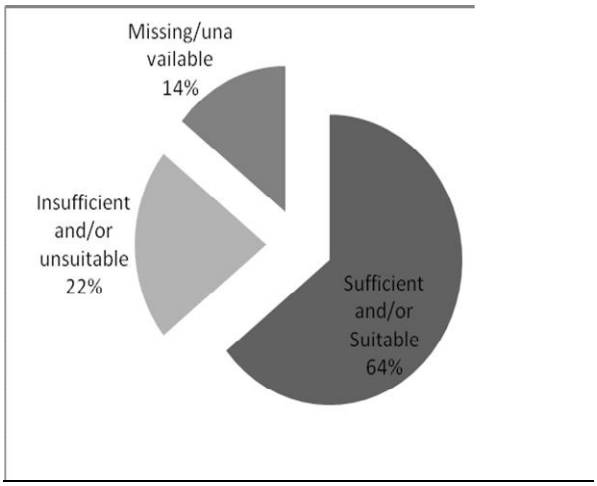
Figure 4: The proportion of buildings with or withoutsufficient and or/ suitable emergency lighting

Emergency lighting: The survey found out that, 64.29 % of the buildings had sufficient and suitable emergency lighting, 21.43% were either insufficient or unsuitable while 14.29% of the buildings had no supply dedicated for emergency

The deficiency was found to be due to poor or improper maintenance and/or sheer negligence. Batteries kept for supplying power to the lights during emergencies are rarely checked to ascertain their condition nor replaced after they are commissioning.

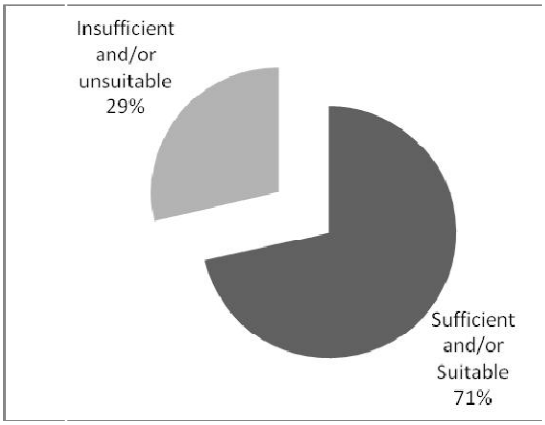
Figure 5: The proportion of buildings with or withoutsufficient and or/ suitable smoke control system

Smoke control system: NBC Life safety chapter IV provide for provision of such facilities for control of smoke and/or fumes in workplaces or occupancies. Smoke control is mainly done mechanically through stair and lobby pressurization to prevent smoke from spreading and entering the escape route or other areas in the building. As presented in the analysis above, 14.29% of the buildings had sufficient and suitable smoke control systems, 78.57% were insufficient or unsuitable and 7.14% had no any smoke control mechanism.

Insufficiency or unsuitability of the smoke control systems and the ventilating systems was to compromise to fire doors, for instance, hinged, broken etc., poor workmanship during repairs and poor or improper maintenance and inspection of the systems.

The survey shown that, the systems are rarely tested to confirm their efficacy due to the cost factor and lack of expertise. Tests on stair and lobby pressurization are a rigorous process that will require experts.
