Road Pothole Detection

Abstract: *Highways and roads are arguably the most used forms of transportation in our day and age and their safety and condition is very important. While Image Processing for maintenance and detection in the transportation field has gained popularity over the last half-century thanks to development in technological areas, there is still more that we can learn and apply as Image Processing is still not utilized in this field to its fullest. The aim of this study was to explain Image Processing techniques and how it can be utilized in a multitude of scenarios in highway and road maintenance. This study describes Image Processing as a whole and continues with how Image Processing is used in the detection and maintenance of the following: Potholes, Rutting of Asphalt Terrain, Pavement Cracks and Surface Roughness which are hazards when it comes to road and highways. In addition, the effectiveness of these methods is explored and evaluated through research and comparison of the methods at hand, with attention towards accuracy and precision. Results showed promising views on the usage of Image Processing in these fields, as a generally easy and cost-effective wa

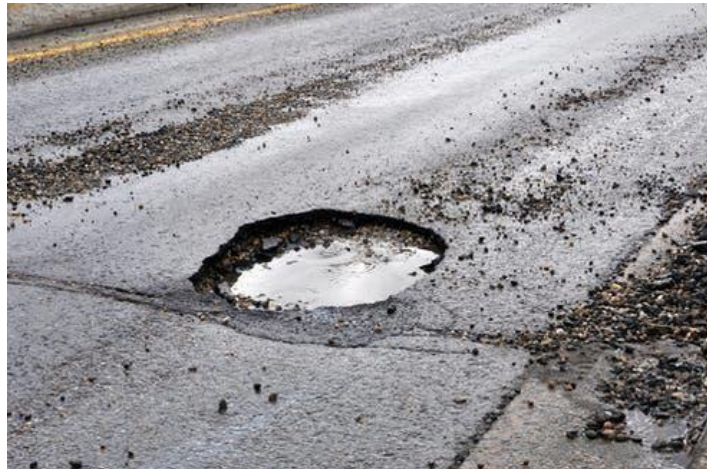
Pothole Example

Potholes are deformations that form on a road surface, which can be problematic, if the necessary road inspections are not done and they are allowed to form. They can lead to vehicle damage and even accidents if left unchecked. Before going to the process of how they can be detected using image processing, it is important to understand how they are formed. According to [6], potholes which are a bowl-shaped deformity can be caused by internal effects like pavement erosion due to water accessing it, change in climate like large amounts of rainfall and external factors such as poor manufacturing and large amounts of traffic. Figure 1 below shows an image of a pothole.

As can be seen from the image, these potholes can be a nuisance, as they are difficult to see when driving. So, this makes their detection an important part in maintenance and the fixing process. This is where image processing comes in to play. As technology has improved it has become easier to use image processing in the detection of these potholes. However, there are steps when it comes to image processing and the first can be specified as image segmentation. "Image segmentation is the crucial first step of pavement distress detection. Its accuracy and reliability are critical for subsequent pothole identification" [7]. Knowing this, it can be said that the method or methods chosen for image segmentation are important. [8]

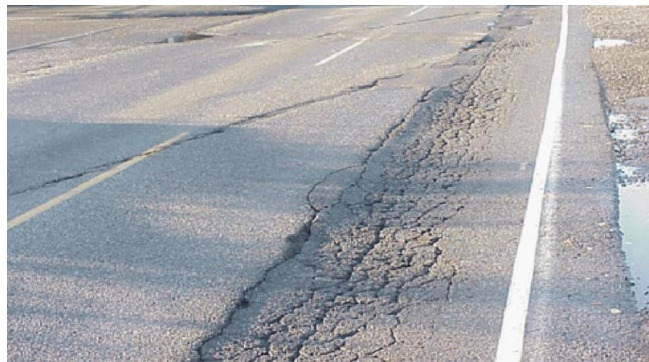
Rutting is a phenomenon whereby their sure surface depressions in the wheel path of the vehicles. Shearing and pavement uplifts occurs mostly along the sides of the rut. These may appear particularly after rains when the road surfaces are filled with water. There are two types of rutting; mix rutting and subgrade rutting. Mix rutting occurs when the subgrade does not rut but the pavement surface exhibits wheel path depressions due to compaction or mix design problems. Subgrade rutting occurs when the subgrade exhibits wheel path depressions due to heavy loading. These may cause hydroplaning which is a hazardous condition that causes a pull towards the rutting paths.

Figure 3: Rutting example

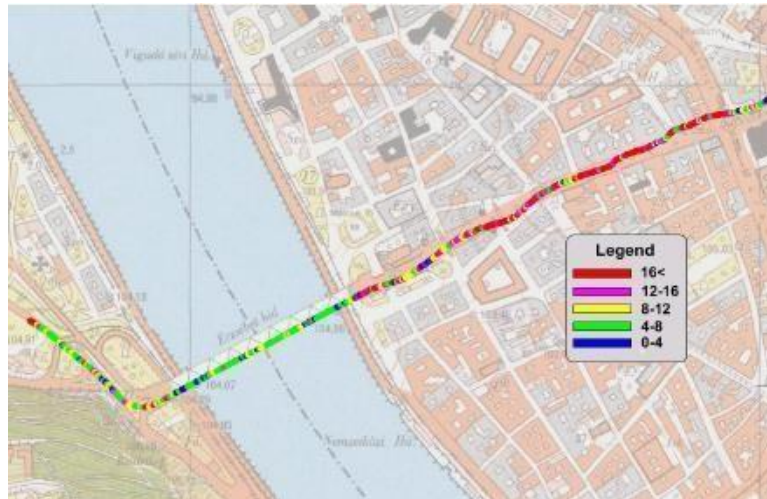
Figure 7: IRI map derived from laser markers below the tires [23]

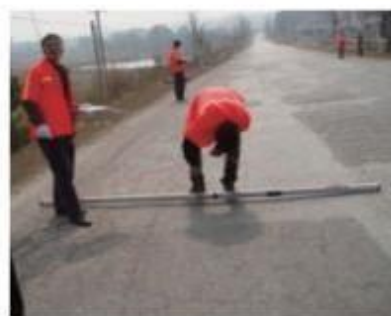
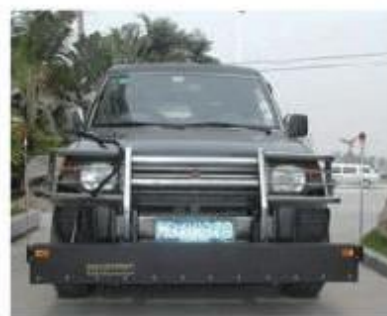
Another thing that was mentioned in report was that no qualified computers needed to do measurements of this method. In this report, authors mentioned that they use software in PC with Windows 7 operate system, 2.9GHz CPU and 2G bytes RAM, which is almost available in every house today. In Figure 9, outcomes of landmark distributed measurements are shown. As it can be observed, results of measurements are so close to each other even though disturbance was applied. Same outcomes can be observed in shadow disturbance measurement. All data are from [24].

(a) straight edge measurement

(b) laser optical measurement

Figure 8: Road surface roughness measure methods [24]
